STRUCTURAL INTEGRITY ASSESSMENT

Kemron Environmental Services
1359-A Ellsworth Industrial Boulevard
Atlanta, Georgia 30318

Deferiet Paper Mill Site
400 Anderson Avenue
Deferiet, New York

November 2020

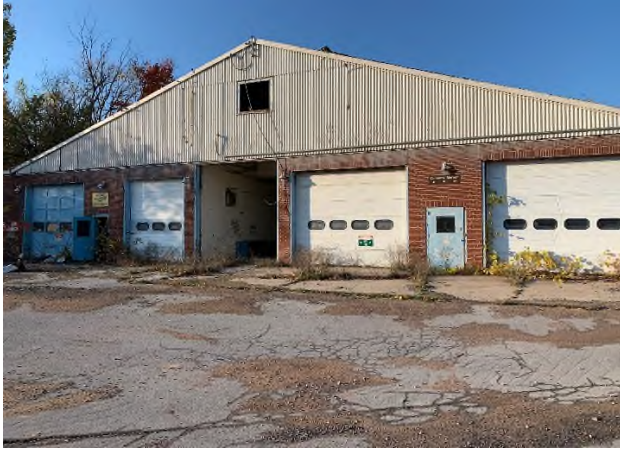
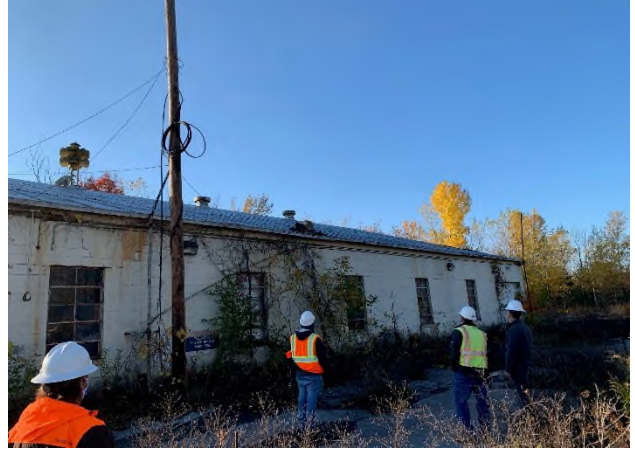
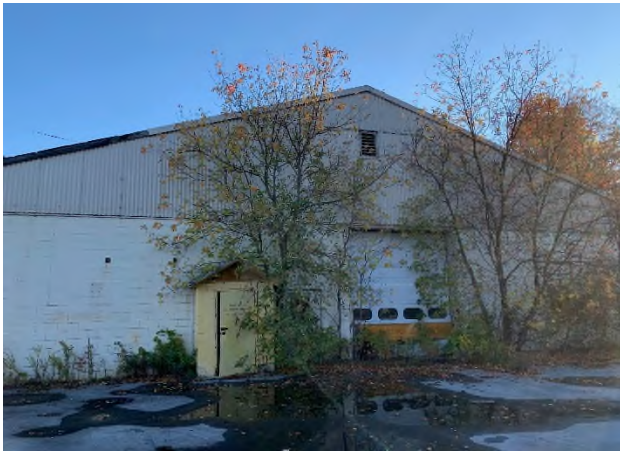
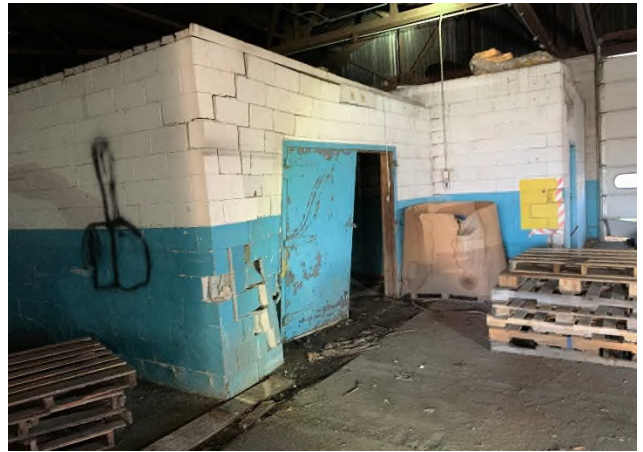
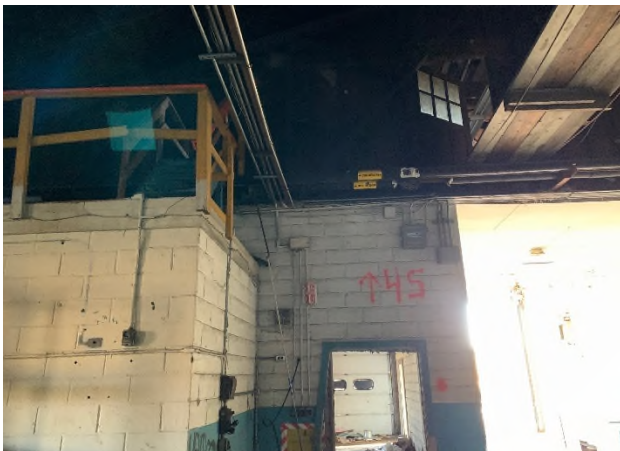
The Company Garage is a single-story concrete block/brick and steel support structure of approximately 10,000 square foot in size. Based on inspection of the building, the structure is in generally good condition with no obvious structural integrity issues observed. Therefore, it is NEU-VELLE's judgement that safe removal of bulk or loose asbestos and/or encapsulation could be accomplished in this area. However, there is an interior masonry block room constructed within the building which shows signs of failing (shifting joints). Any work within this interior room should not be conducted and care should be taken if working in the area.

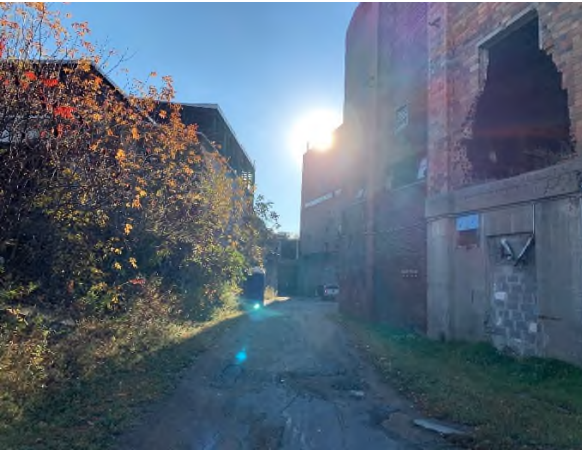
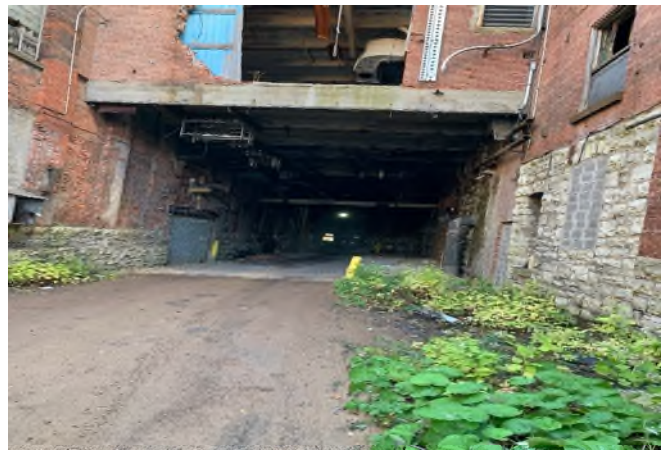
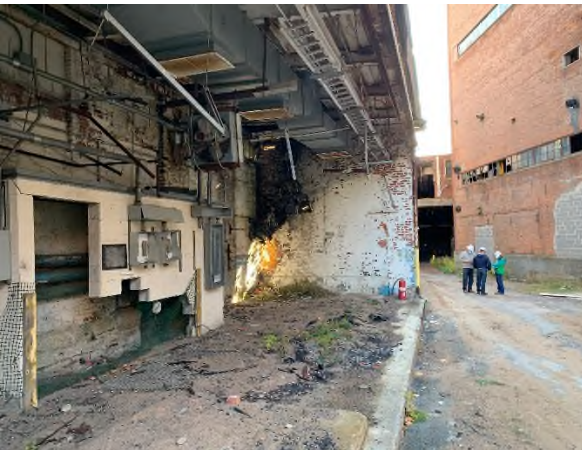
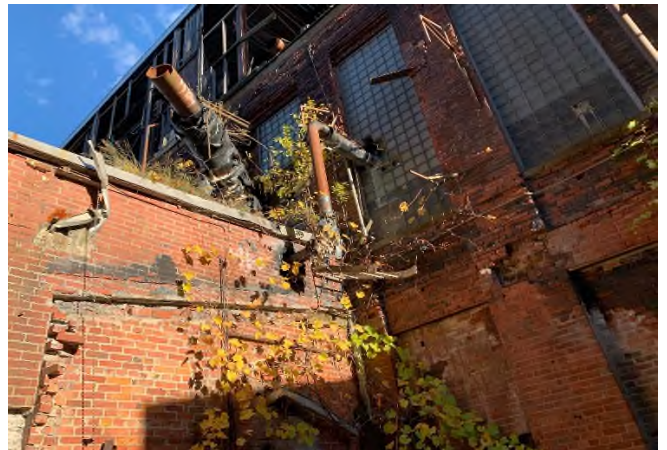
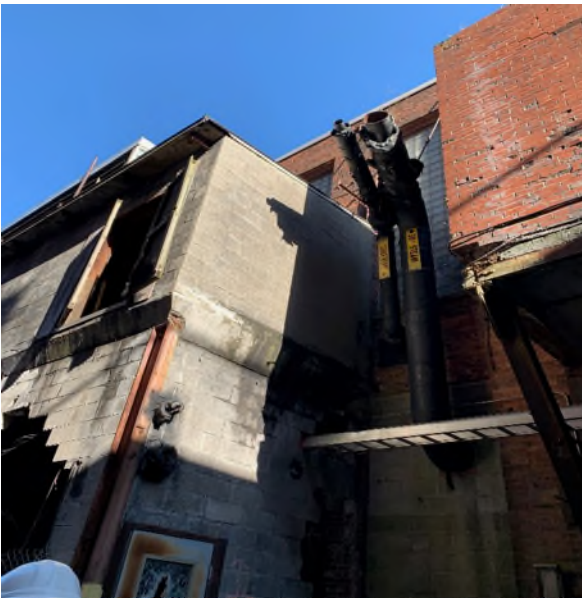
Easement

As indicated previously, the site currently has an active hydroelectric plant which is operated by Brookfield Renewable Power, LLC. An access route to the Brookfield plant is provided by an easement area that runs approximately north to south through the plant site. Based on inspection of the structures adjacent to the easement area, they are in generally good condition with no obvious exterior structural integrity issues observed. Therefore, it is NEU-VELLE's judgement that safe removal of bulk or loose asbestos and/or encapsulation could be accomplished in this area. However, care should be taken in areas of loose brick on various areas of the structures during work activities.

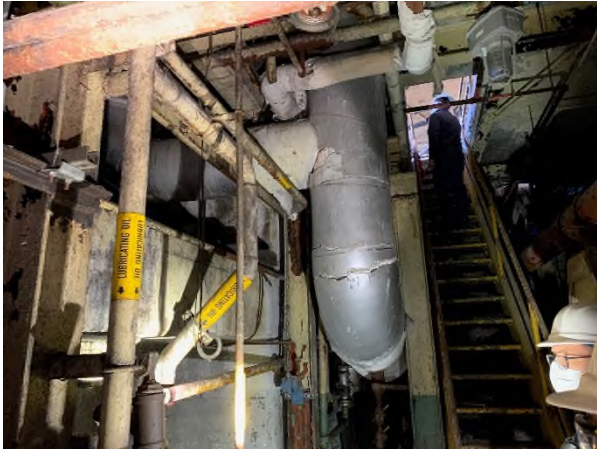
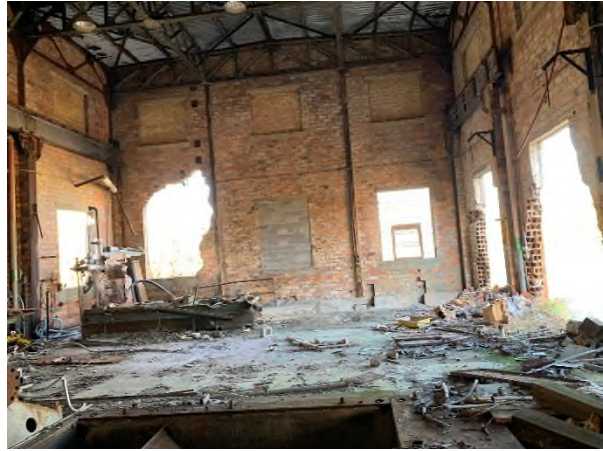
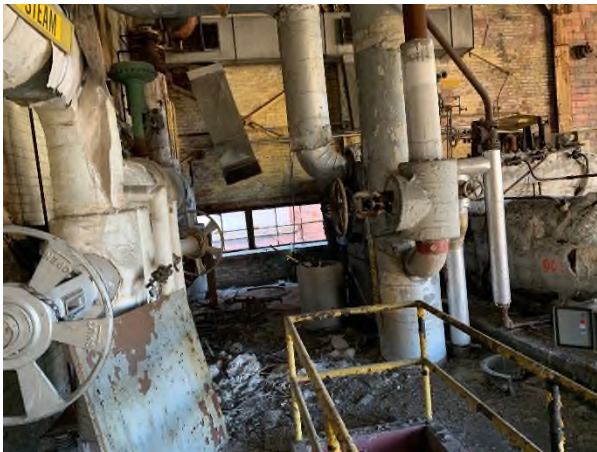
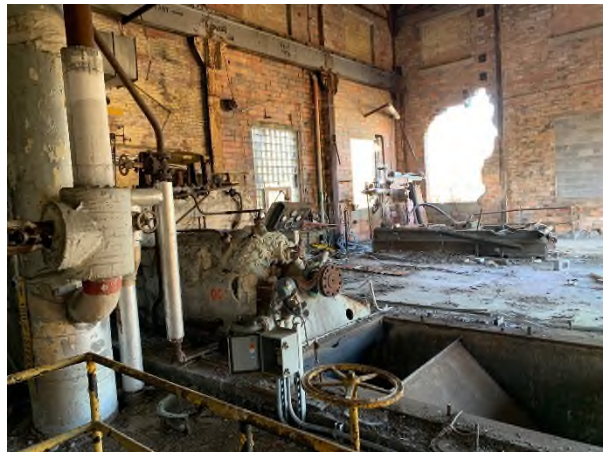
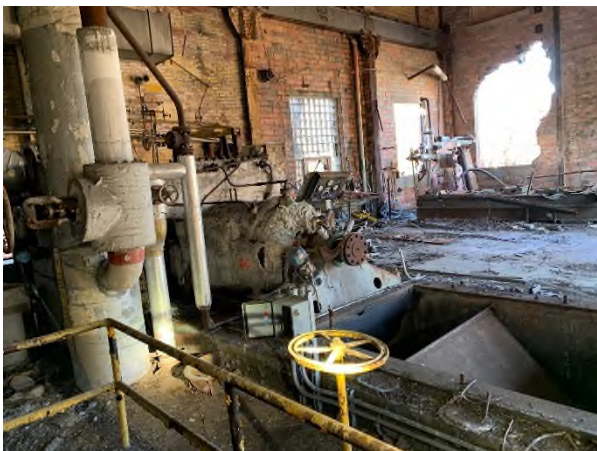
The Turbine Room is a multi-story brick and steel support structure of approximately 6,000 square foot in size. Based on inspection of the building, the structure is in generally good condition with no obvious structural integrity issues observed other than there has been brick removed on the second floor of the structure to apparently gain access to the interior of the structure for equipment removal. It is NEU-VELLE's judgement that safe removal of bulk or loose asbestos and/or encapsulation could be accomplished in this building as long as care is taken in areas where there is loose brick/block or overhanging equipment (i.e. piping, etc.).

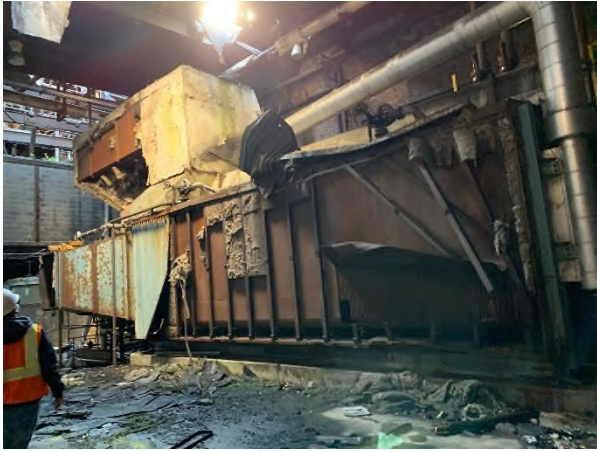
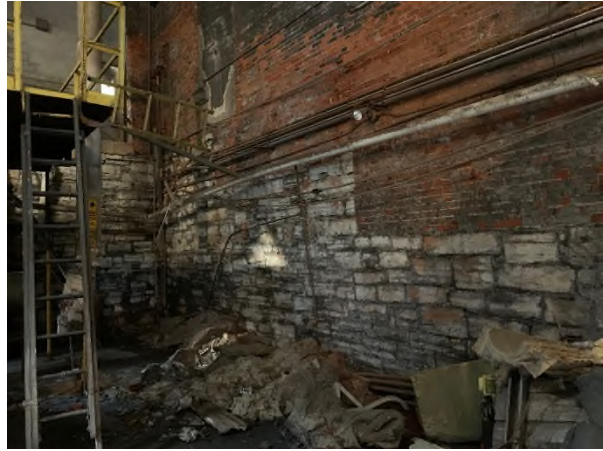
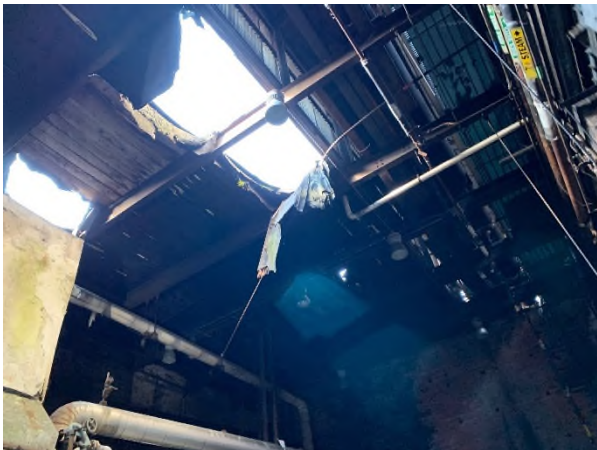
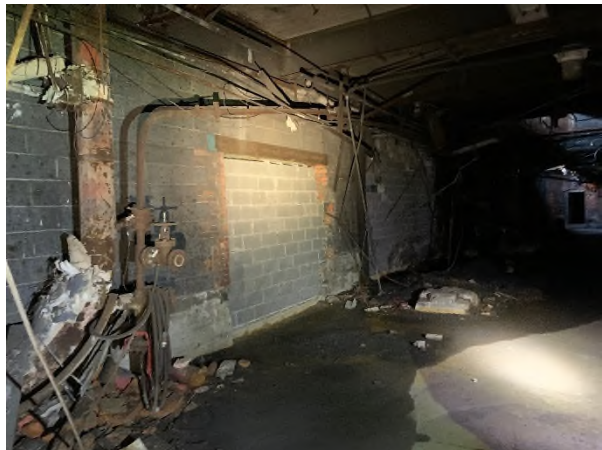
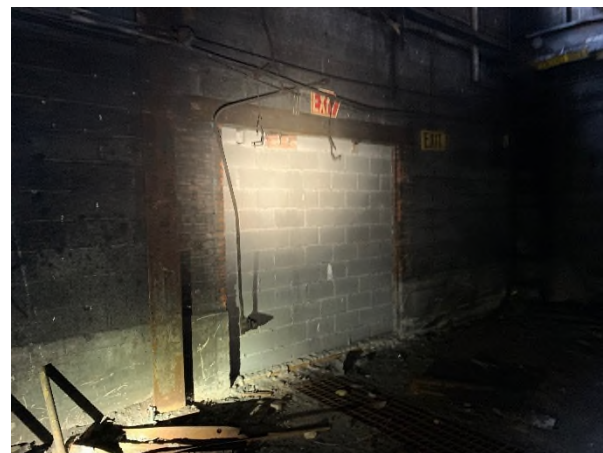
The Boiler Room is a multi-story brick and steel support structure of approximately 32,000 square foot in size. Based on inspection of the building, the structure is in generally good condition with no obvious structural integrity issues observed other than areas of loose brick throughout the structure. Therefore, it is NEU-VELLE's judgement that safe removal of bulk or loose asbestos and/or encapsulation could be accomplished in this building as long as care is taken in areas where there is loose brick/block or overhanging equipment (i.e. piping, etc.).

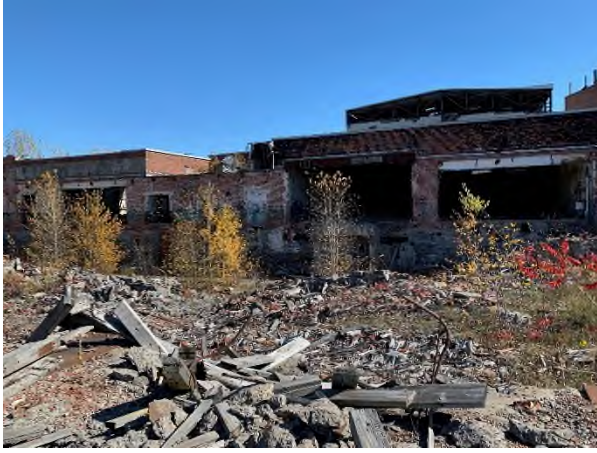
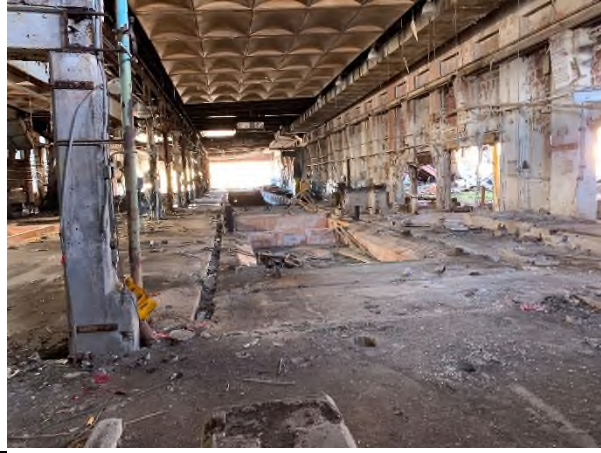
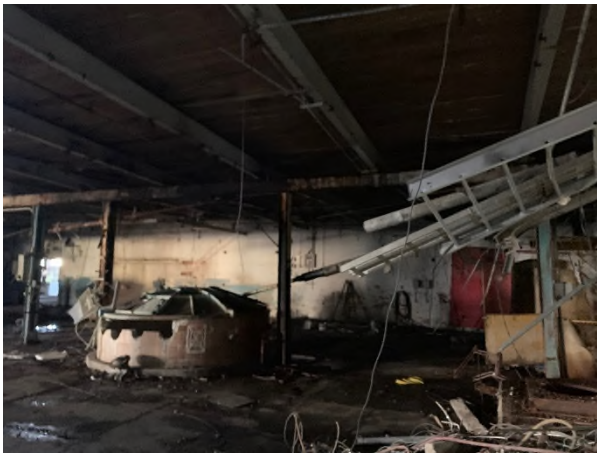
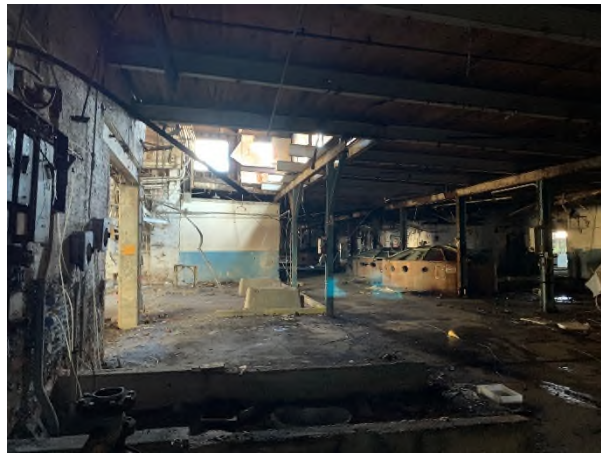
The Machine Room is a mainly one-story brick and steel support structure of approximately 25,000 square foot in size. Based on inspection of the building, the structure is in generally good condition with no obvious structural integrity issues observed other than areas of loose brick/block throughout the structure. Therefore, it is NEU-VELLE's judgement that safe removal of bulk or loose asbestos and/or encapsulation could be accomplished in this building as long as care is taken in areas where there is loose brick/block or overhanging equipment (i.e. piping, etc.).

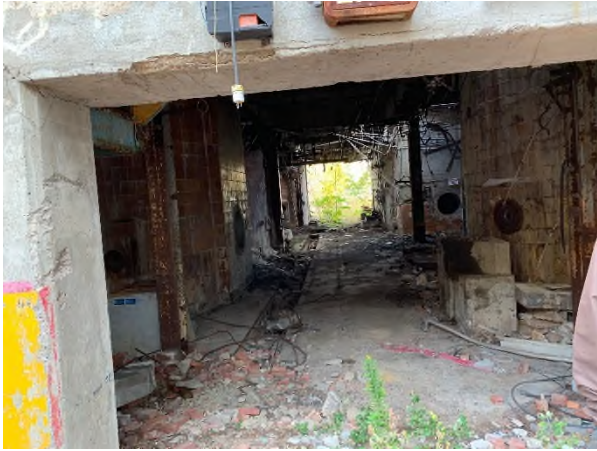
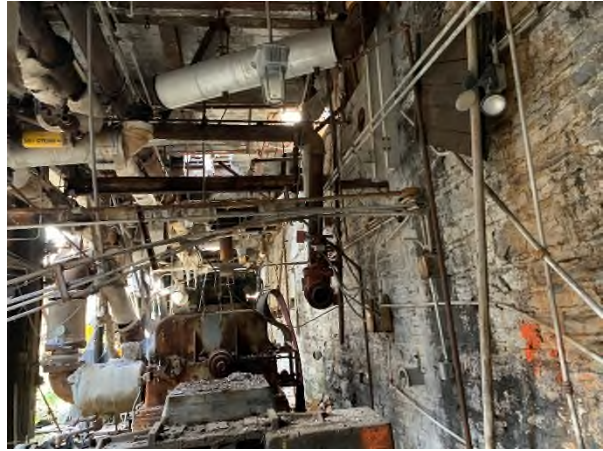
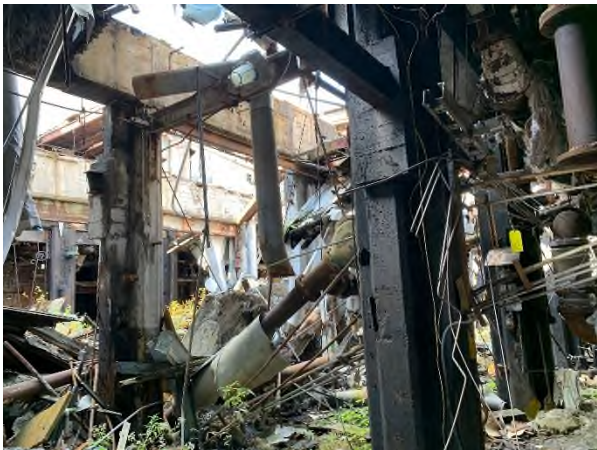
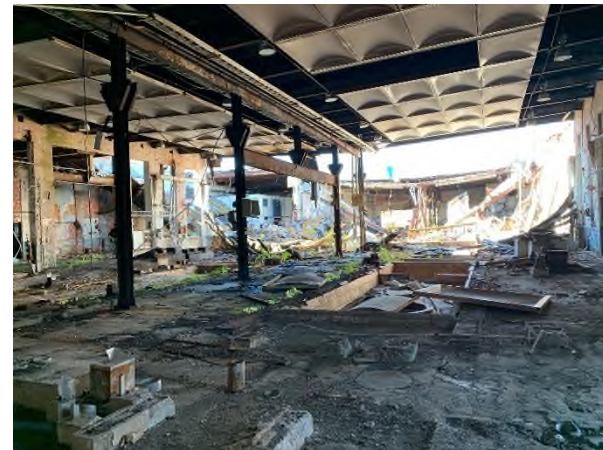
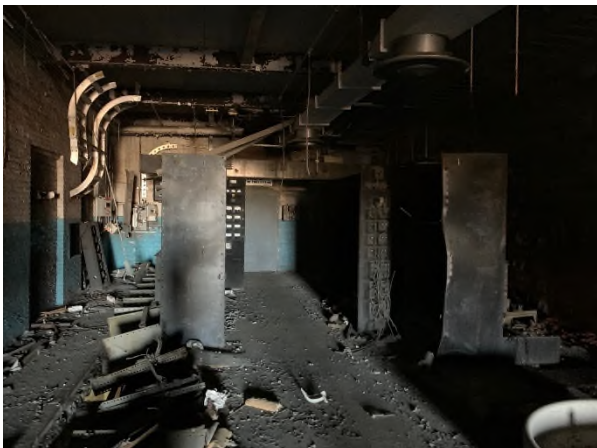
The Equipment Room is a multi-story brick and steel support structure of approximately 25,000 square foot in size. Based on inspection of the building, the structure is in generally good condition with no obvious structural integrity issues observed other than the area has undergone demolition activities and areas of the building are collapsed. Therefore, it is NEU-VELLE's judgement that safe removal of bulk or loose asbestos and/or encapsulation could be accomplished in this building as long as care is taken in areas where there is loose brick/block, collapsed roof structures, or overhanging equipment (i.e. piping, etc.).

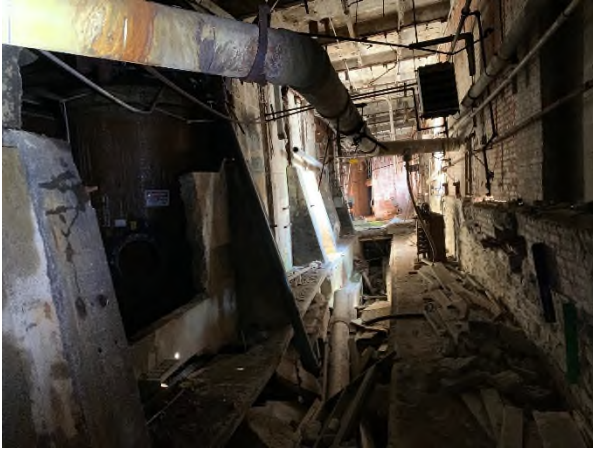
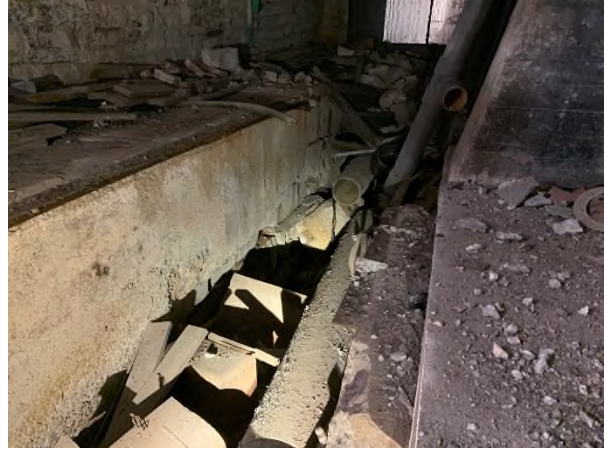
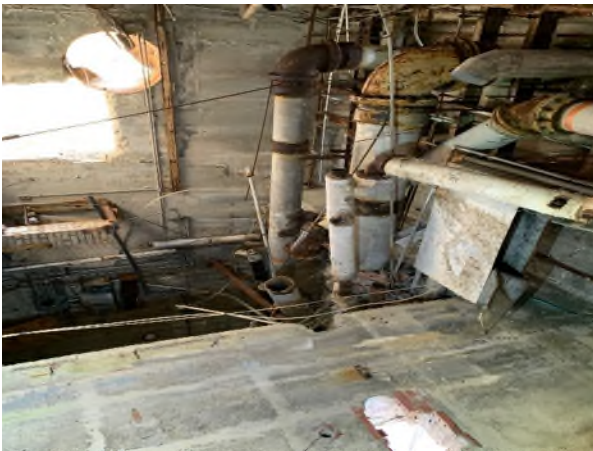
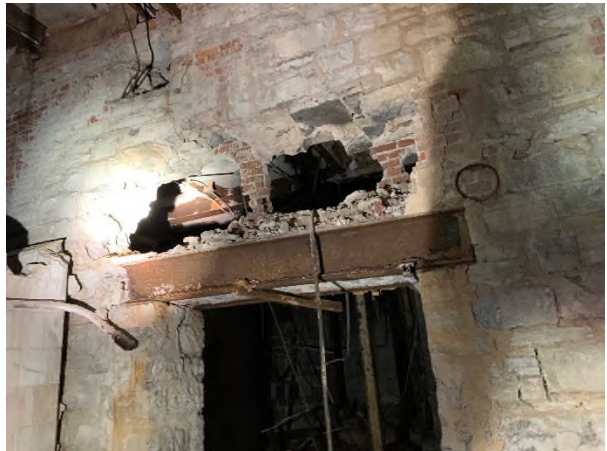
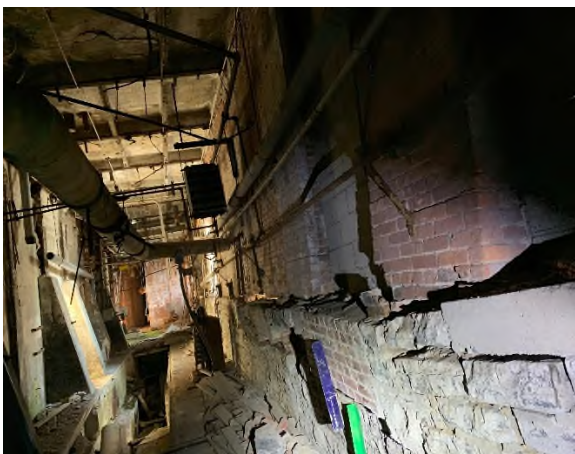
The Wet/Beater Room is a one-story brick and steel support structure of approximately 30,000 square foot in size. It is located adjacent to the Brookfield Renewable Power which shares a common wall with this area/room. Based on inspection of the building, the majority of the structure is in generally good condition with no obvious structural integrity issues observed. However, the wall adjacent to the Canal shows significant signs of foundation deterioration in the area just adjacent to the power plant. Based on discussions from Brookfield Renewable Power representatives, significant settlement and deformation of the foundation has been recently observed (underwater visual inspection, etc.). Therefore, it is NEU-VELLE's judgement that safe removal of bulk or loose asbestos and/or encapsulation should not be conducted within 50 feet of this wall. In addition, based on inspection of the foundation in this area, NEU-VELLE does not believe that temporary shoring and/or supports can be to protect the structure from collapse. It is recommended that a thorough underwater inspection of the foundation be conducted to design a remedy for this area, or it be properly raised. However, other areas of the building can be safely entered as long as care is taken in areas where there is loose brick/block, collapsed roof structures, or overhanging equipment (i.e. piping, etc.).

However, it is NEU-VELLE's judgement that the Wet/Beater Room wall adjacent to the Brookfield Power Plant is not safe and work should not be conducted within 50 feet of this wall. In addition, based on inspection of the foundation in this area, NEU-VELLE does not believe that temporary shoring and/or supports can be utilized to protect the structure from eventual collapse. It is recommended that a thorough underwater inspection of the foundation be conducted to design a permanent remedy for this area, or it be properly raised.

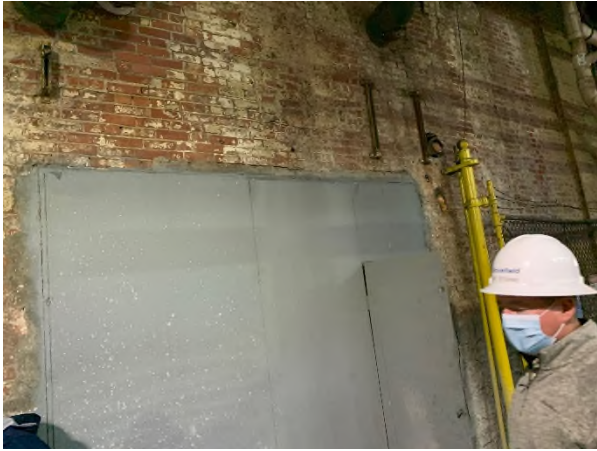
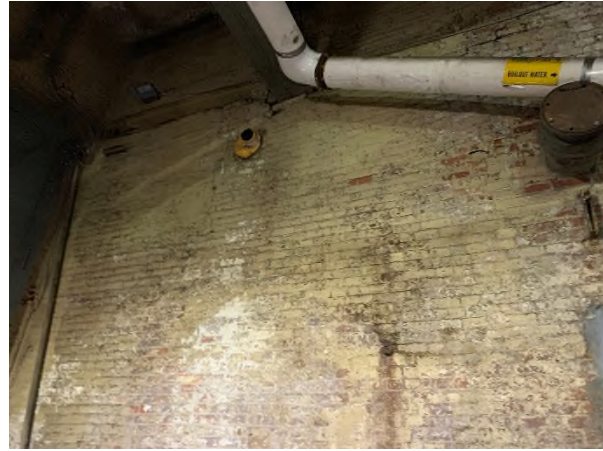
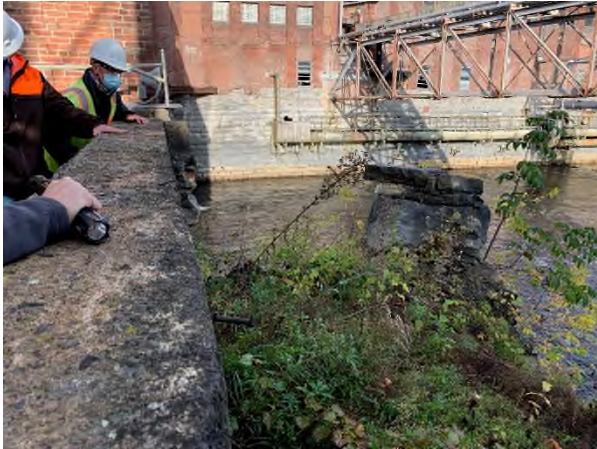
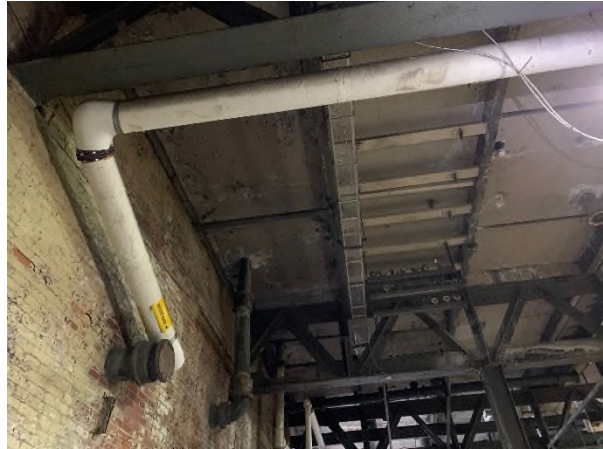
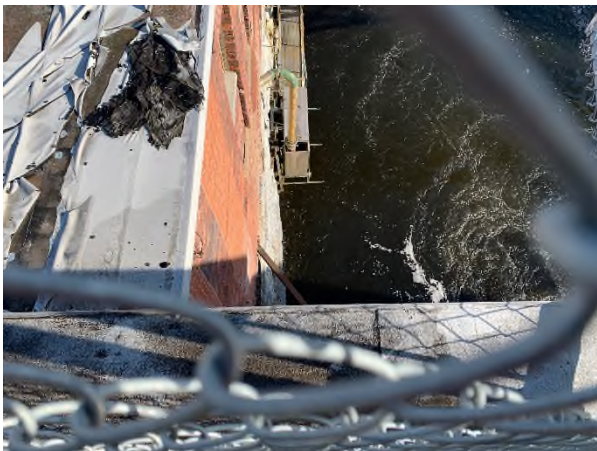
Brookfield Building & Shared Walls

The Brookfield Renewable Power Plant building is a multi-story brick and steel support structure of approximately 15,000 square foot in size. It is located adjacent to the Wet/Beater Room. Based on inspection of the building, the structure is in generally good condition with no obvious structural integrity issues observed. In addition, the common wall between the plant and the Wet/Beater appears to be in generally good condition with no apparent structural issues. However, as indicated above, the wall adjacent to the Canal shows significant signs of foundation deterioration in the area just adjacent to the power plant. In the event that this walls foundation becomes increasingly compromised, failure of the Wet/Beater Room wall could occur and compromise the structural integrity of the Brookfield Renewable Power Plant. Therefore, it is recommended that a thorough underwater inspection of the foundation be conducted to design a remedy for this area, or it be properly raised.
